Manhole Inspection Summary

Manhole # S07CC2011MH

Insp Date: **8/8/06 9:37 AM**

Location Address: **2800 BERKELEY AVE**

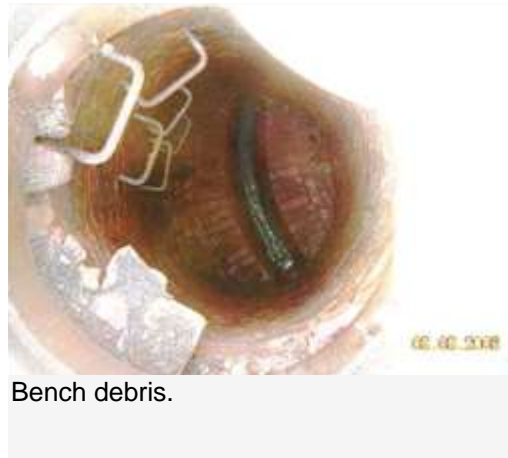
Top View

Bench debris.

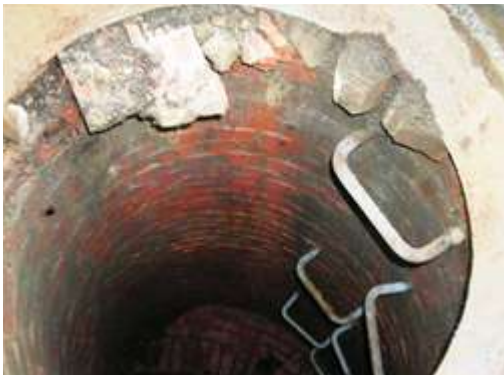
Defect

Frame leaks. Adjustment deterioration, loose brick and infiltration. Barrel infiltration.

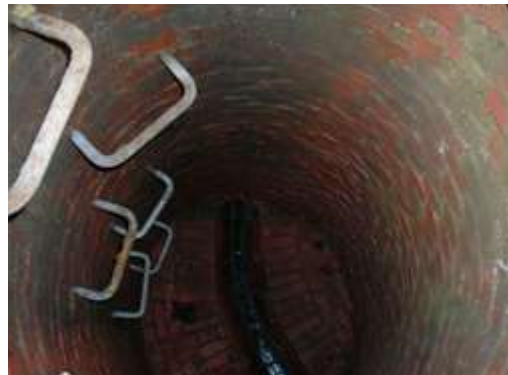
Defect

Adjustment and Barrel infiltration.

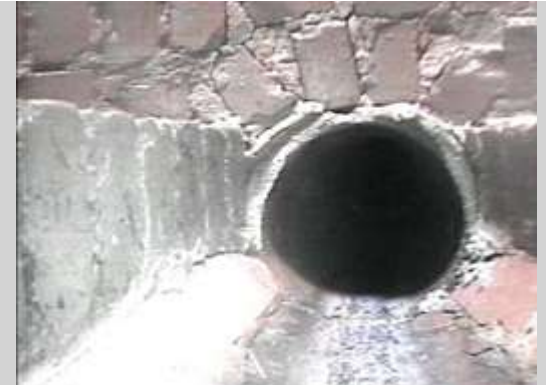
8 in. Circular Gravity Sewer Pipe Out @ 12 O'Clock

Barrel deterioration and infiltration.

Infiltration: **Evidence** Pipe Seal Cond: **Unknown**

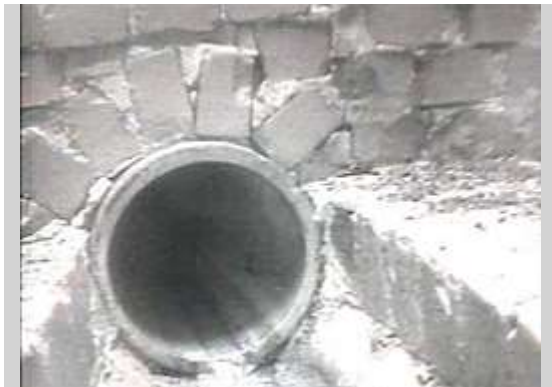
8 in. Circular Gravity Sewer Pipe In @ 5 O'Clock

Infiltration: **Evidence** Pipe Seal Cond: **Unknown**
